Supplement of

Distribution of nutrients and dissolved organic matter in a eutrophic equatorial estuary: the Johor River and the East Johor Strait

Amanda Y. L. Cheong et al.

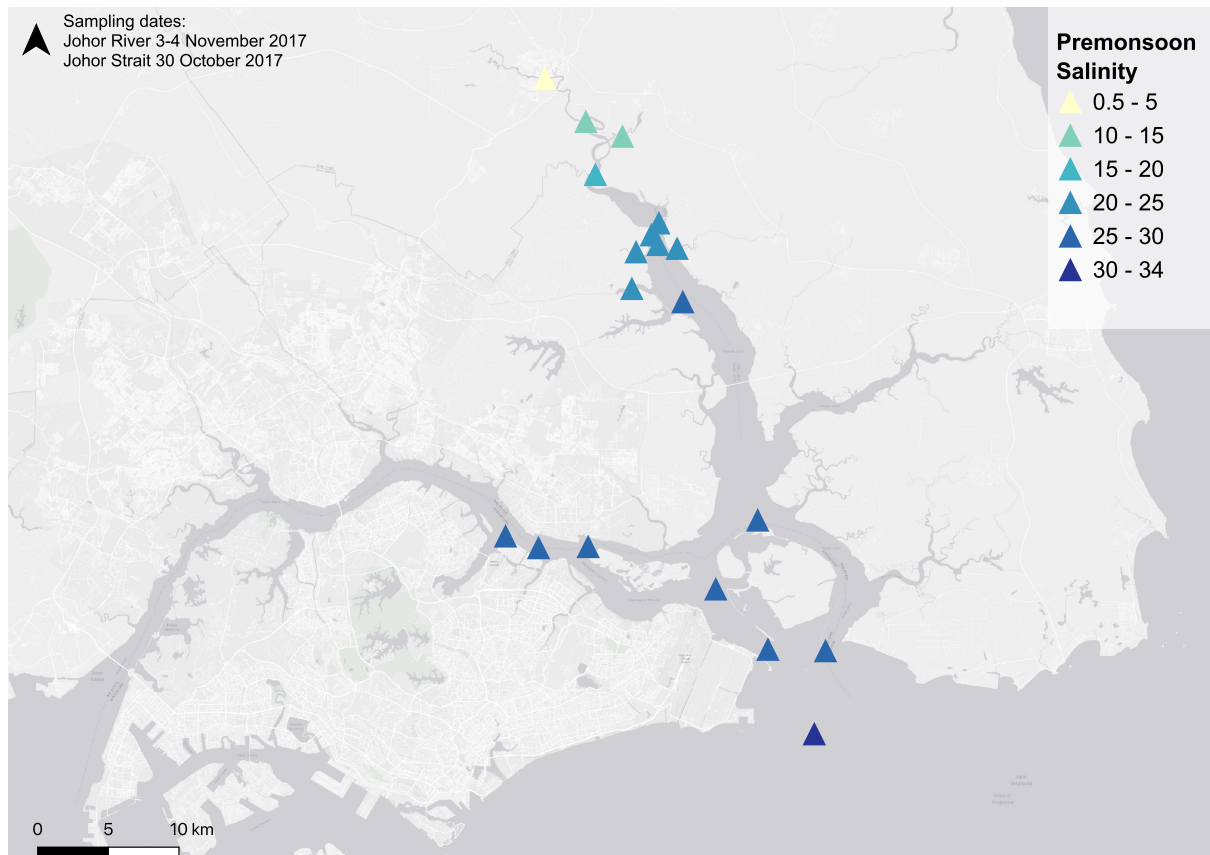
Figure S1: Surface salinity measured during pre-monsoon sampling on 30 October 2017 (for Johor Strait stations) and on 03–04 November 2017 (for Johor River stations). Basemap credit: ESRI.

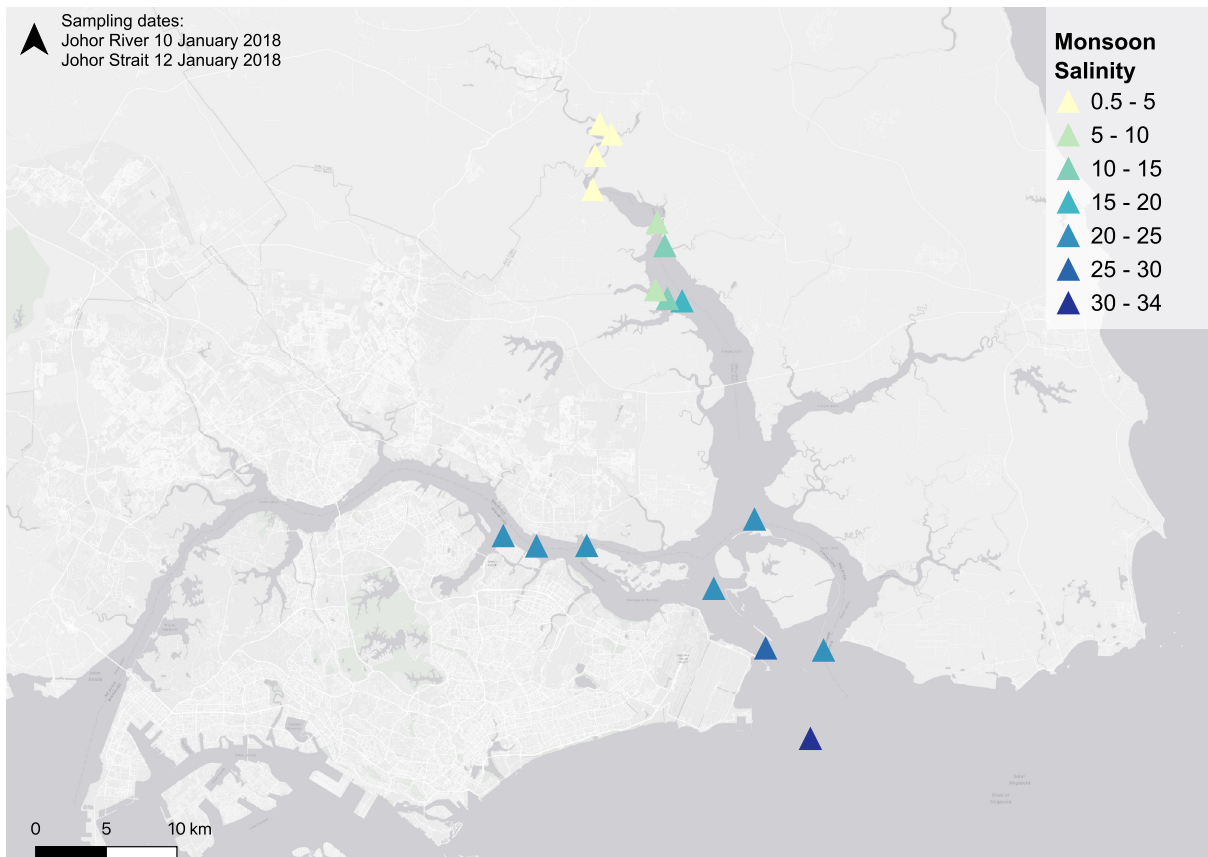
Figure S2. Surface salinity measured during northeast monsoon sampling on 12 January 2018 (for Johor Strait stations) and on 10 January 2018 (for Johor River stations). Basemap credit: ESRI.

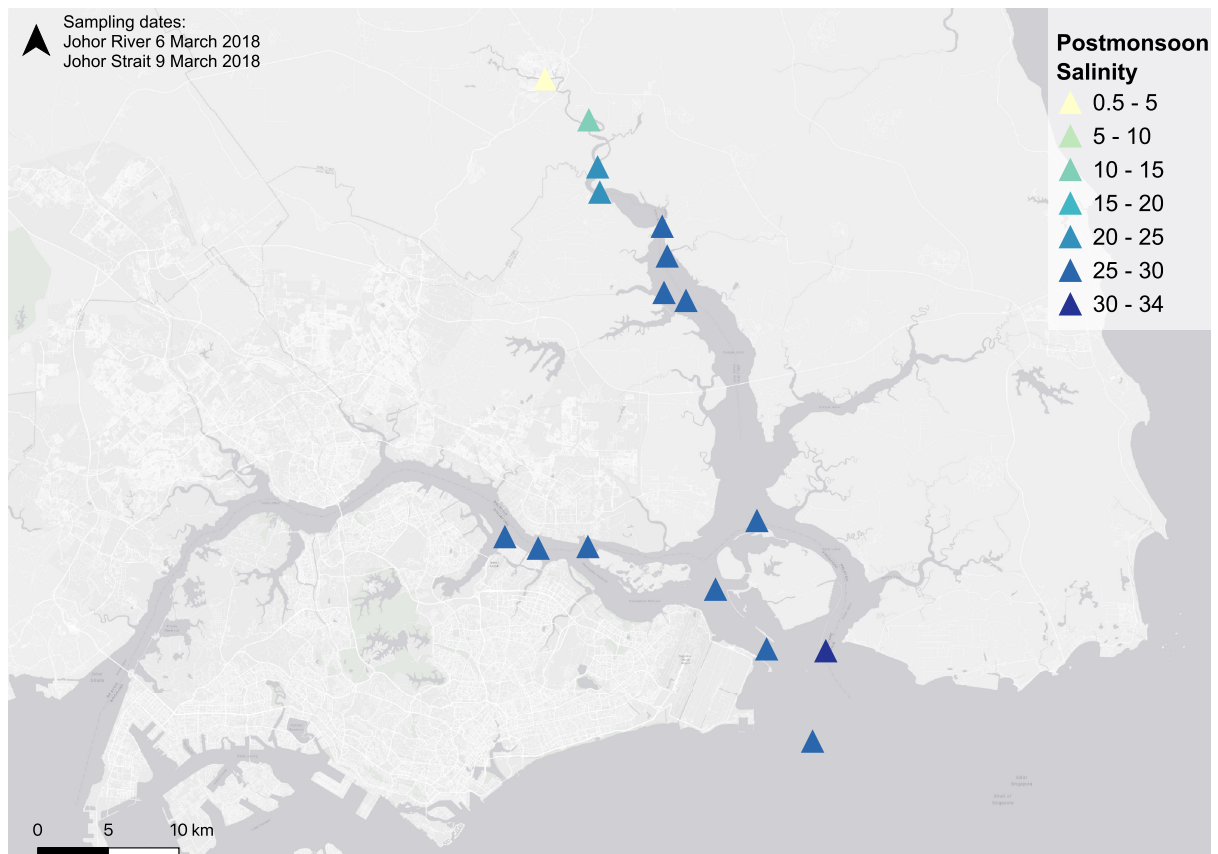
Figure S3. Surface salinity measured during post-monsoon sampling on 09 March 2018 (for Johor Strait stations) and on 06 March 2018 (for Johor River stations). Basemap credit: ESRI.
